REPORT ON  
WRONG-WAY AUTOMATIC SIGN, LIGHT AND HORN DEVICE

**LIBRARY COPY** June 28, 1965  
Materials & Research Dept.

65-48

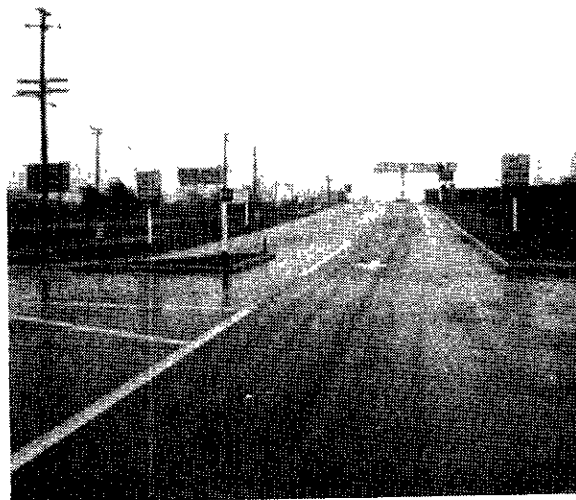
Figure 8  
Off-ramp terminus after sign changes.

<u>Sign Code</u>	<u>Sign Message</u>	<u>Remarks</u>
1. G77R	<u>South</u> <u>99</u> <u>North</u>	300' North of Mack Road (New Sign) (Figure 5)
2. G78R	<u>Frontage Rd.</u> 99 SOUTH	Replaced "LOS ANGELES" sign 500' North of Gore (Figure 6)
3. R7R	KEEP RIGHT	Replaced smaller "KEEP RIGHT" without arrow
4. W5R(Lt)	(Curve left arrow)	Removed median sign
5. R11R	DO NOT ENTER	Replaced white on black with black on white (Added additional sign.) (Figures 7 & 8)
6. R65R	WRONG WAY	New Signs added to R11R's (Figure 9)

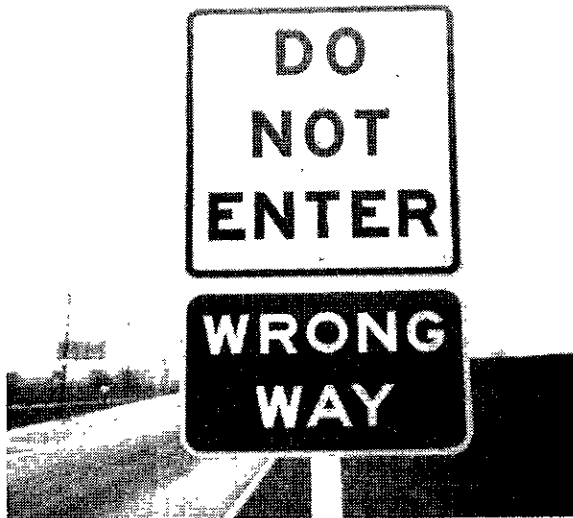
Figure 9

Close up of new R11R  
augmented with red  
background "WRONG WAY".
